Manhole Inspection Summary

Manhole # S39C2_007MH

Location Address: **4014 Orchard**

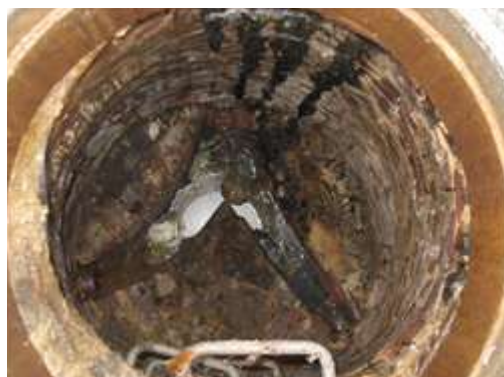
Top View

Count: **5** Missing: **0** ☒ **Corroded**

steps

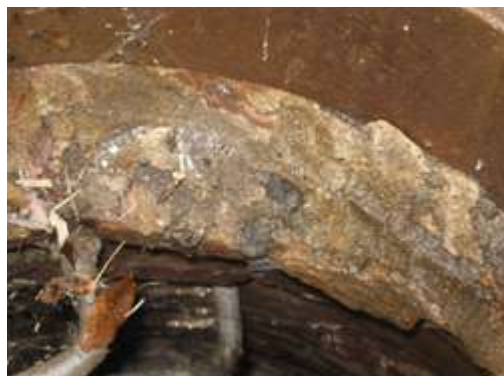
Defect 1

Offset: **1.5** (in.)

frame offset

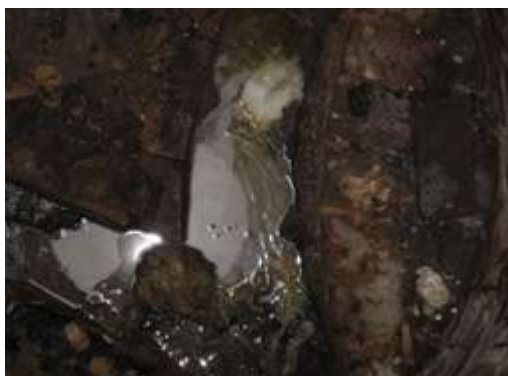
Defect 2

Condition: ☐ Sound ☐ Cracked ☐ Root Intrusion ☐ Deteriorated ☐ Leaks ☒ **Debris**

debris

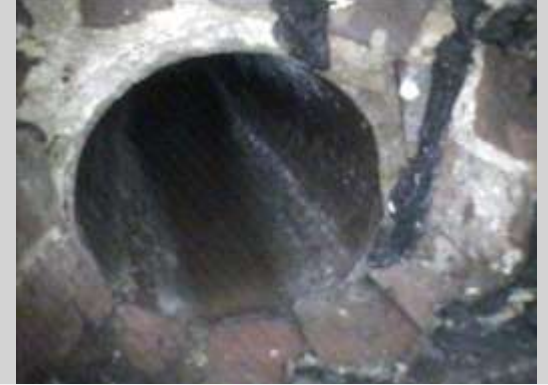
12 O'Clock Outflow

8 in. Circular Gravity Sewer
Pipe Out @ 12 O'Clock

Pipe Height: **9.6** (in.) Rod and Bar (Angled)
Pipe Material: **Clay** ☐ Pipe Lined
Invert Depth: **9.70** (ft.) Flow Characteristics: **Slow**
Deposits: ☐ None ☐ Mud ☒ **Sludge** ☐ **Debris** ☐ Grease
Silt Depth: **1** (in.) Deposits Extent: **Heavy**
Infiltration: **None** Pipe Seal Cond: **Sound**

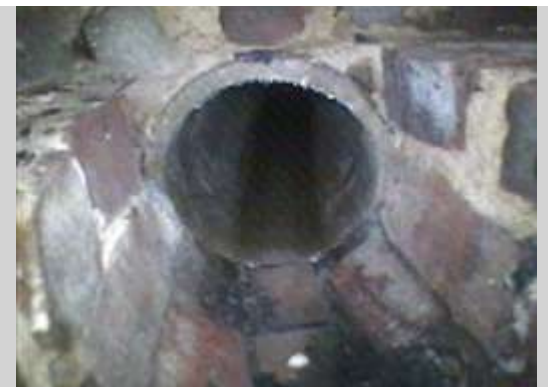
5 O'Clock Inflow

6 in. Circular Service Sewer
Pipe In @ 5 O'Clock

Pipe Height: **7.2** (in.) Rod and Bar (Angled)
Pipe Material: **Clay** ☐ Pipe Lined
Invert Depth: **9.42** (ft.) Flow Characteristics: **Slow**
Deposits: ☐ None ☐ Mud ☐ Sludge ☒ **Debris** ☐ Grease
Silt Depth: **1** (in.) Deposits Extent: **Medium**
Infiltration: **None** Pipe Seal Cond: **Sound**

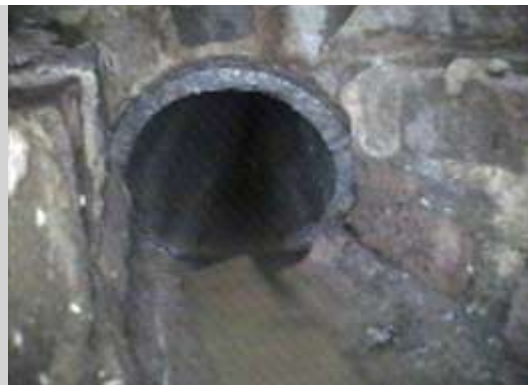
8 O'Clock Inflow

6 in. Circular Service Sewer
Pipe In @ 8 O'Clock

Deposits: ☐ None ☐ Mud ☐ Sludge ☒ **Debris** ☐ Grease

Silt Depth: **0.5** (in.) Deposits Extent: **Medium**
